The Chernobyl Reactor: Design Features and Reasons for Accident

Mikhail V. MALKO

Abstracts

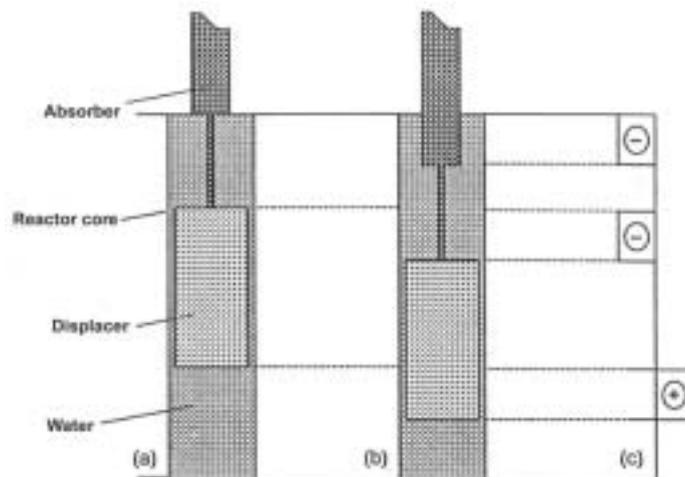
The significant shortage was also in the design the SAR, MR and ER absorbers of the RBMK reactor. These absorbers had special graphite displacers in the length of 4.5 m [10]. By a withdrawal of the SAR, MR and ER absorbers up to their extreme top position above the core, the midpoint of each displacer is at the midpoint of the core. Because their length (4.5 m) is less than the height of the core (7 m), the water columns in the height of 1.25 m are formed below and above the displacers. On moving down of absorbers into the core, their displacers displace water columns from the lower part of the core. Thus, inserting of absorbers from their extreme top position introduces a positive reactivity into the core because graphite absorbs neutrons much less than water. This effect of absorber displacers is shown in Fig. 4. It was known by operators of RBMKs. They named it the “end-rods effect”. Specialists named the “end-rods effect” as the positive reactivity surge. It was not fully understood by them because it appeared occasionally and only by some neutrons distributions in the core. For example, in one document of the Chief Designer organization it was told that the positive reactivity surge could appear only in case of neutron field disturbed downwards [10]. This statement was wrong. It is known that before pressing the button AZ-5 the neutron field was distorted upwards and not downwards. This fact says about misunderstanding by the Chief Designer organization of the real nature of the positive reactivity surge caused by inserting of absorbers from their extreme top position.

FIG. 4. Schematic presentation of the reactivity inserted by moving of CPS absorbers from their extreme top position.
 (a) manual regulation rod is withdrawn;
 (b) manual regulation rod is at the initial insertion stage;
 (c) schematic presentation of the change in the reactivity by insertion of the rod [5].

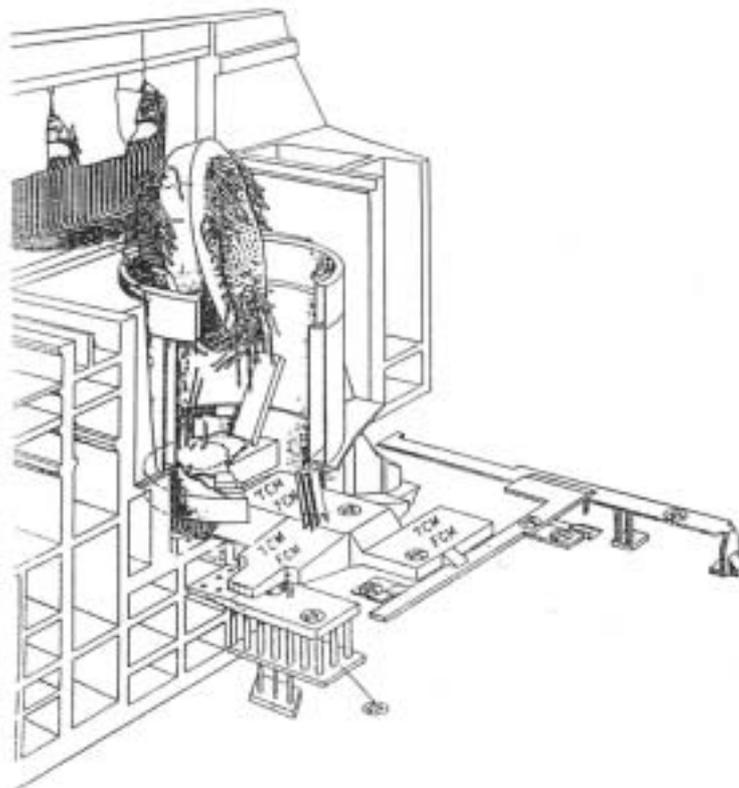
The explosions at 01 hr 24 min completely destroyed the core of the reactor of the Unit 4 [12]. Walls and the ceiling of the central hall were demolished. Ceilings of the premises of the steam separators were displaced and walls were destroyed. Premises housing the main circulating pumps as well as two stories of the de-aeration stack were demolished. The reactor emergency cooling system was completely destroyed from the north side of the reactor building and buried with frame details. The upper metal structure together with top covering (the summary weight 2,000) and rests of the steam-water system were thrown into vertical direction and fell on the rib with the inclination angle 15° [12]. The artist picture in Fig. 4 shows its position after the explosions as well as the scale of the reactor destruction. The lower metal structure after the explosion went down by 4 m lower than their initial position, crushing the supporting constructions and pulling the water pipeline system. The southeast quadrant of the lower metal structure does not exist. It was destroyed during the accident. The reactor space is empty. It does not contain any more or less large fragments of the reactor laying [12].

In addition to destructions listed here, many other premises and constructions were demolished too. By destruction of the reactor a large amount of core materials were thrown out the core [13]. Large pieces of graphite and whole graphite blocks, fragments of fuel channels and fuel assemblies could be found even in big distances from the reactor [13]. Practically the whole site of the Chernobyl NPP as well as all rooms of the reactor was covered with the graphite dust.

FIG. 5. The state of the reactor section of Unit 4 after the accident (the cut-away view): FCM - fuel containing masses [12].
